红米1S (TD) 三级维修指导

TSIMMPHM1S
红米1S (TD) 三级
维修指导

不开机故障

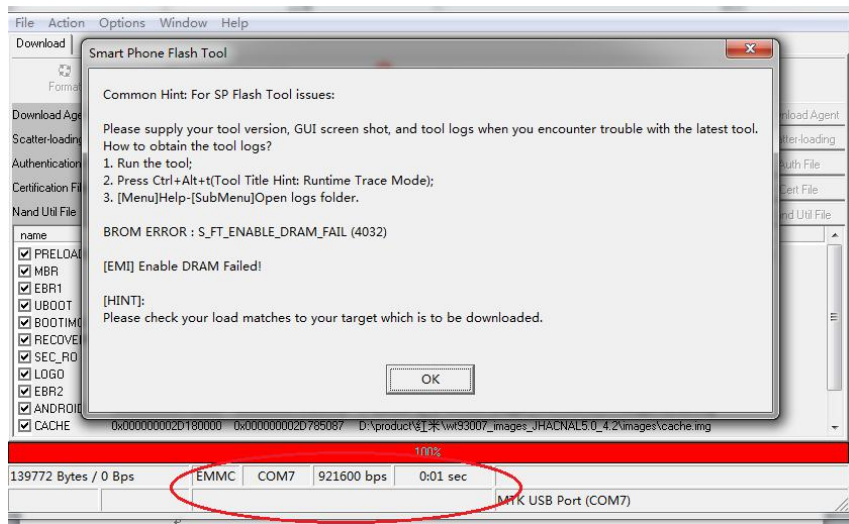
2.3.1 刷机报错信息1：刷机时红条到100%不走报错。下图红圈位置没有USB_HIGH_SPEED显示，也没有USB_FULL_SPEED。

- 1) U501不能被识别
- 2) U501与U201通讯异常导致

这种故障是对U501的检测出现问题，由于U201未能检测到U501造成的。

- 1) 应该先测量U501是否焊好，检查U301供给 U501的电压是否都正常。
- 2) 判断是否由于U201的原因造成不识别U501，考虑U201与U501之间的通讯，数据线、地址线、控制线。

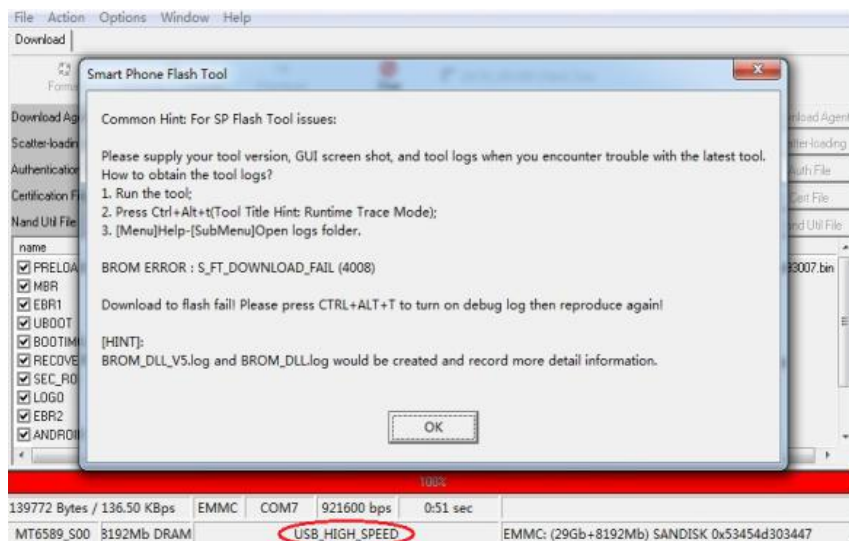
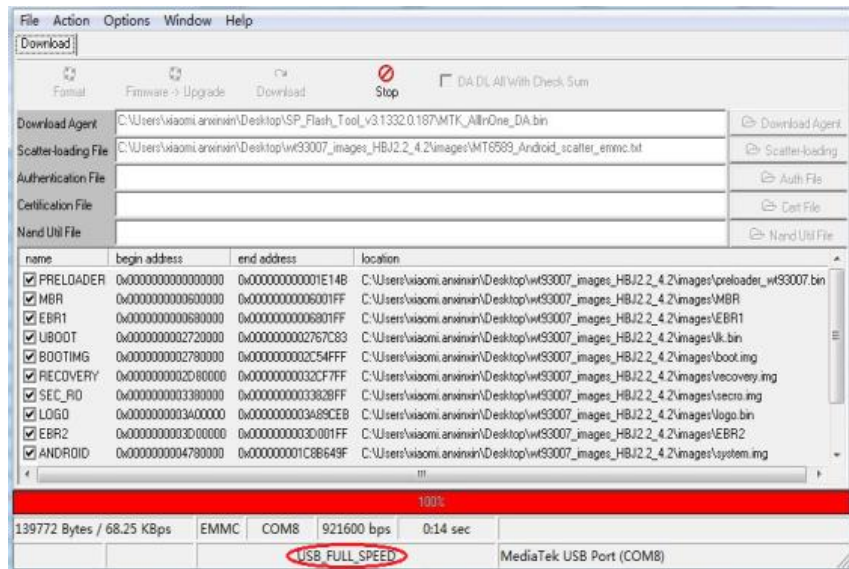
2.3.2 刷机报错信息2：刷机的时候在红色100%报错，有USB_HIGH_SPEED显示或有USB_FULL_SPEED。

- 1) VIO1V8_PMU电压异常
- 2) EMMC_CLK波形异常

这种故障为U501能被识别但是不能刷程序。主要考虑U501的供电电压幅度是否正常，还要考虑U201是否可以向U501内刷程序。检查U201与U501之间的板线。检查EMMC_DAT数据线。

U501的供电VIO1V8_PMU没有的话，刷机机会停在这一步，一般是由U301引起。

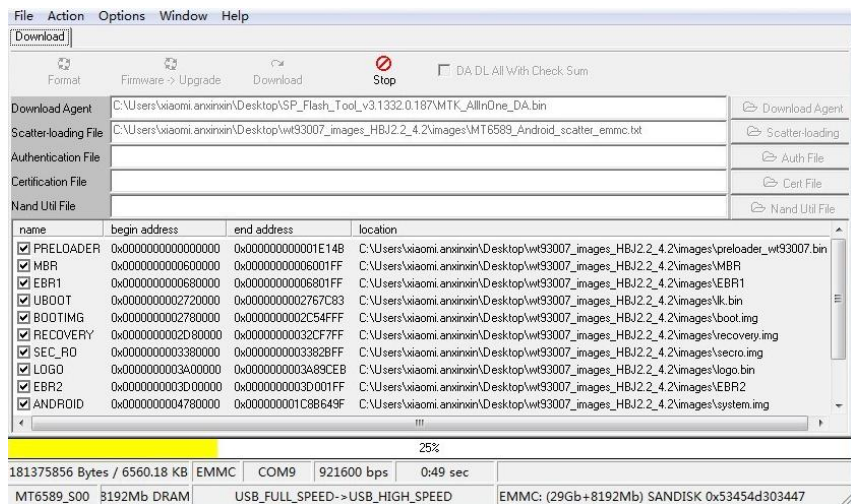
2.3.3 刷机报错信息3：刷机到黄色进度条中报错的，或者到黄色进度条0%不写程序。

- 1) U501本身器件损坏或与U201之间某条数据线地址线有问题
- 2) USB接口焊接不良

这种故障是在往U501中的EMMC部分刷程序的过程出现问题造成的。主要考虑U501本身，U201与U501之间的数据线和地址线，重点应考虑EMMC部分的数据线和地址线。USB接口焊接不良，会出现有时能刷程序有时刷程序在黄条报错的问题。我们曾遇到一块一会能刷过一会刷不过的主板，是由于USB接口焊接不良造成的。

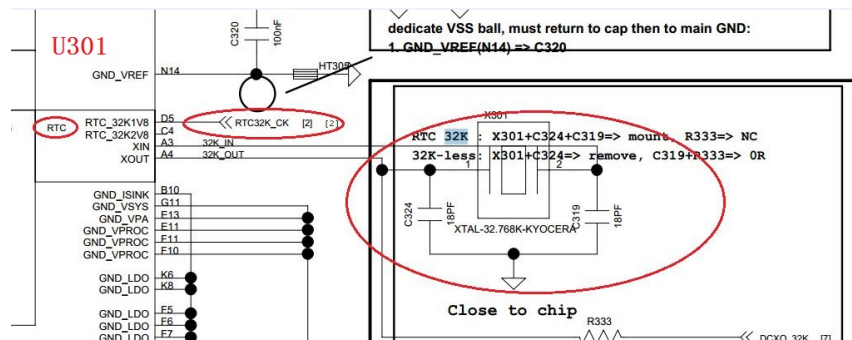
第一例：

故障现象：70ma不开机，端口为MTK。定在100%不能刷机报4001错误

故障器件：Y301

HM主板在刷机的过程中，U201需要32KHz才能匹配刷机时的数据传输。所以主板在更换完U501后，刷机时在很长的时间里报错4001，是因为U501的DDR2存储空间可以被识别，但是数据不能写入造成。所以此故障除了芯片问题还有很大的几率是32KHz的晶振Y301问题。此主板测量没有32khz，更换Y301后修复。同时在考虑32khz的问题时还要注意到32khz的供电VRTC是否有问题。

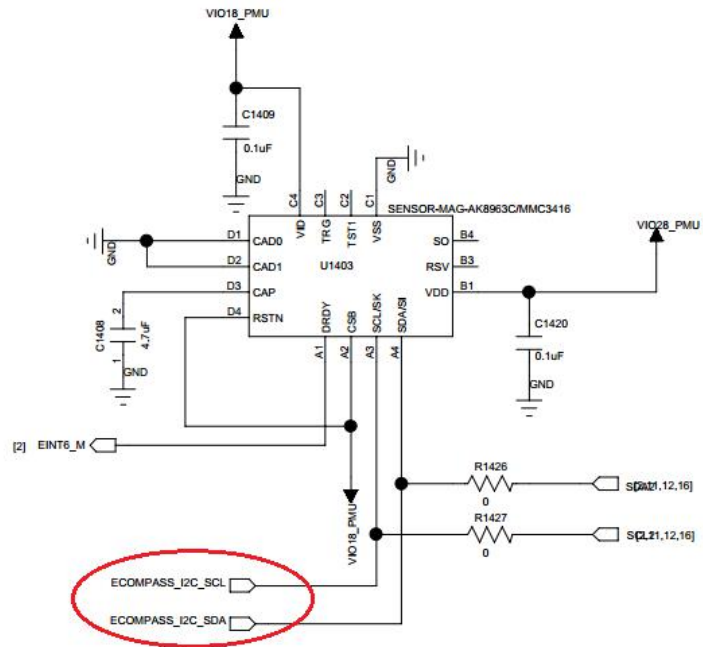
第二例：

故障现象：主板送修不开机，白米重启

故障器件：U1403

检测主板不开机，白米重启，可以刷机但是仍然白米重启，测量ECOMPASS_I2C_SCL没有电压，对地短路，更换U1403后主板修复。

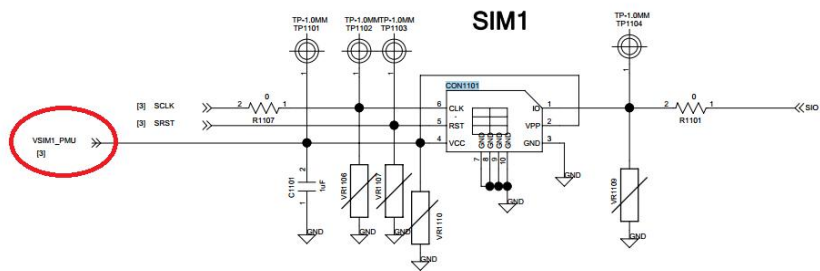
第三例：

故障现象：主SIM卡不识别

故障器件：U301

主板主SIM卡不读卡，测量VSIM1_PMU电压阻值低，更换U301后主板修复。

VSIM1_PMU 为SIM卡的供电。在判断的时候要考虑VSIM1_PMU 的电压是否有3V。

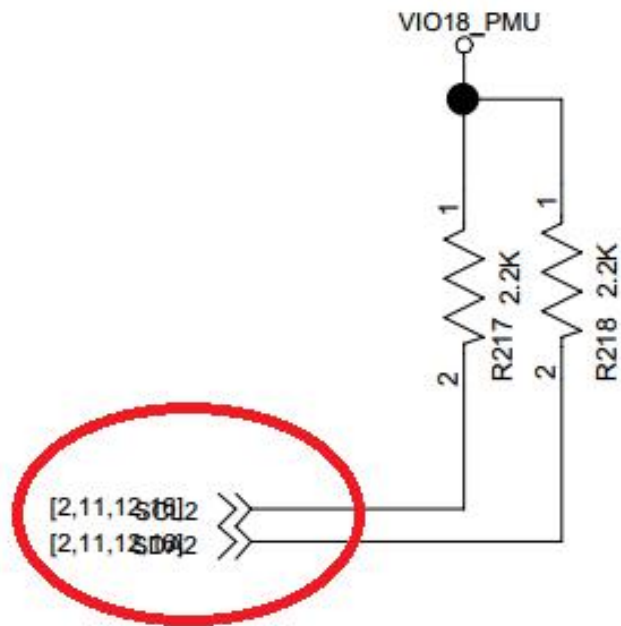
第四例：

故障现象：白米重启

故障器件：R217

白米重启考虑I2C总线，测量发现SCL2阻值异常，观察发现R217虚焊，重新焊接后修复。
