## 8. Level 3 Repair

### 8-1. 부품 배치

# A30 Block Diagram

Date : 2018.11.22  
H/W REV : 0.0

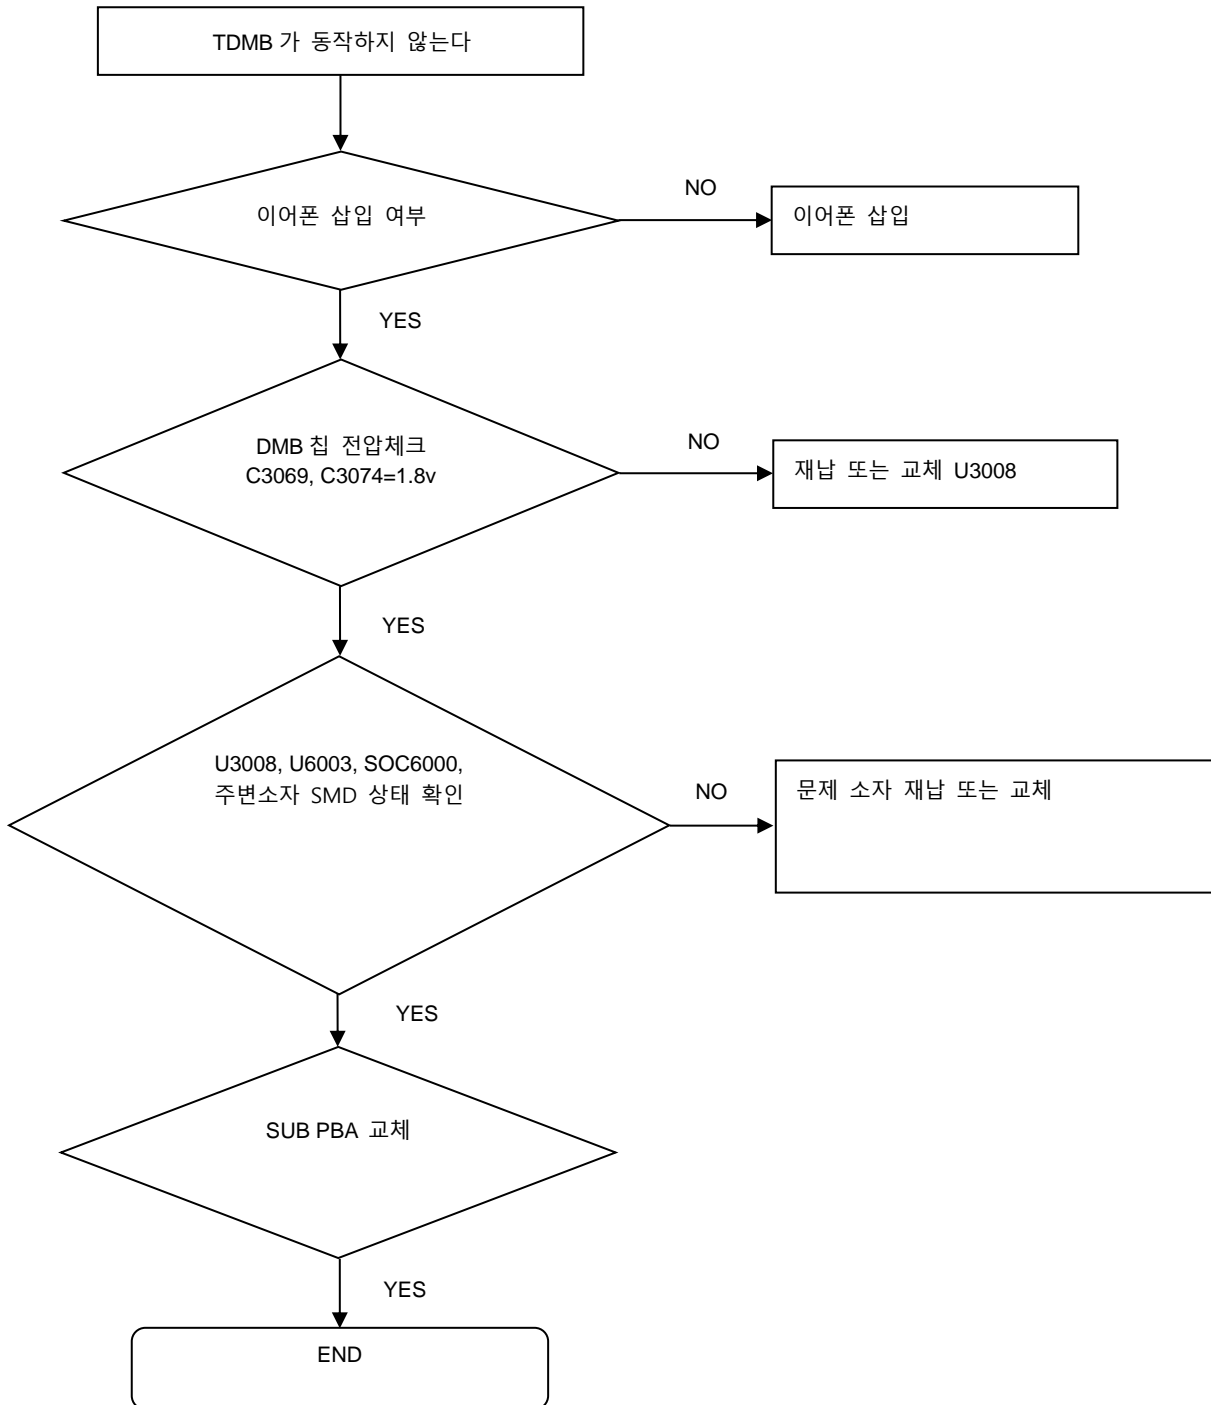
### 8-4-24. TDMB
